Adelaide Central Business District (CBD) Electricity Supply Reliability

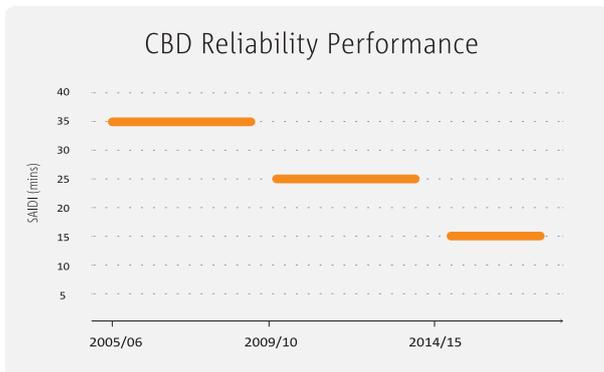
Figure 1

During the last 15 years the reliability performance of the electricity supply in the Adelaide CBD has significantly improved with the average minutes without power for Adelaide CBD customers reducing from 35 minutes to 15 minutes. See figure 1.

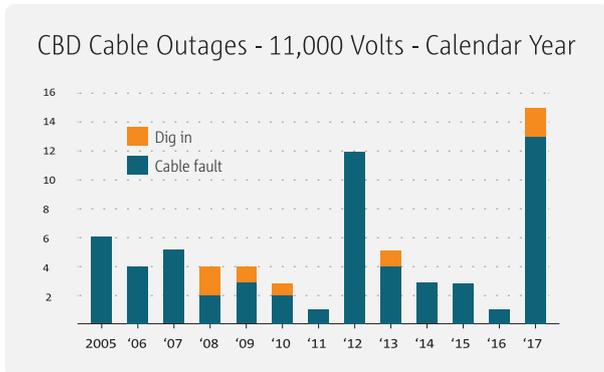
Figure 2

Over the last six months we have seen an unexpected level of failure of our older 11,000-volt underground cables. Several incidents have been caused by third parties disturbing cables. See figure 2. Many of these cables were installed more than 30 years ago and are of lead covered paper insulated construction.

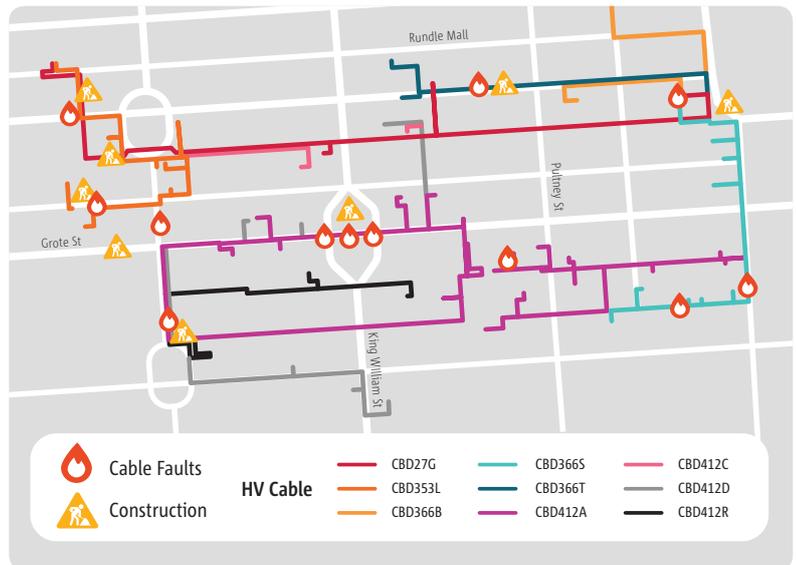
Figure 3

There is no clear pattern of failure with incidents scattered across the CBD. We have observed that most incidents have occurred within a short distance of construction sites and this is being considered as part of an action plan discussed below. See figure 3.
