SA Power Networks Ensuring reliable electricity supply for Adelaide's CBD

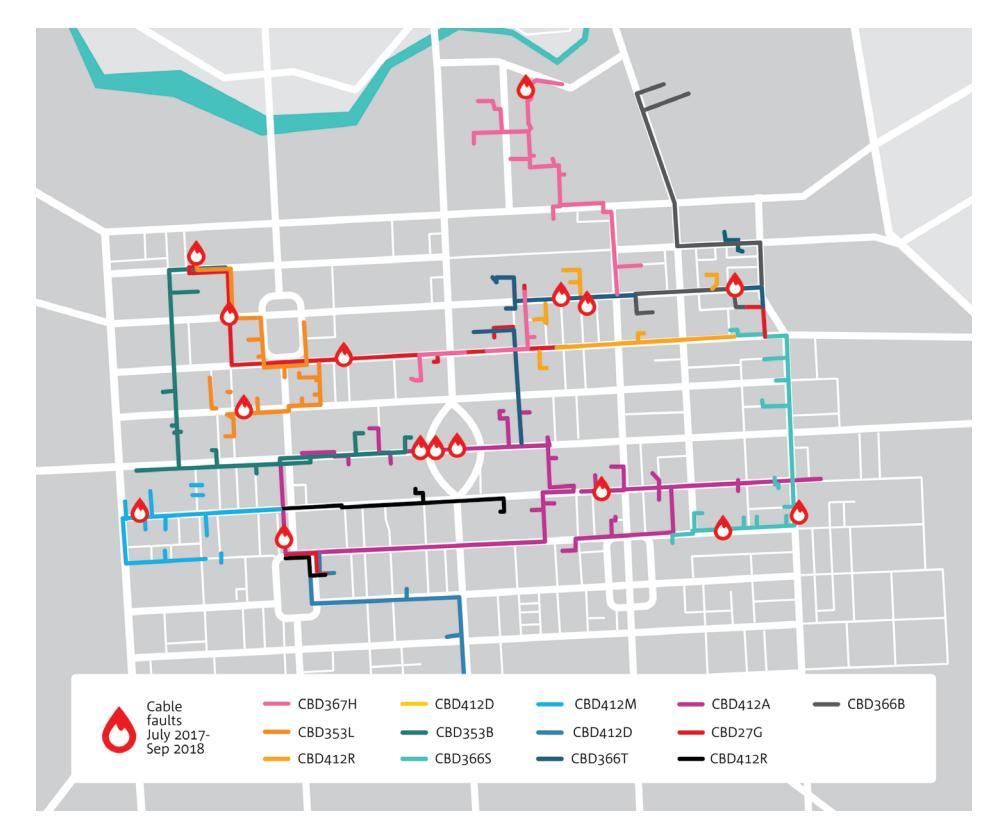
The chart (right) shows the varied location of cable sections that failed, all in different locations except for the three cable faults near Victoria Square. Two of these were due to a cable joint failure and the other a cable insulation failure. This section of cable has been replaced.

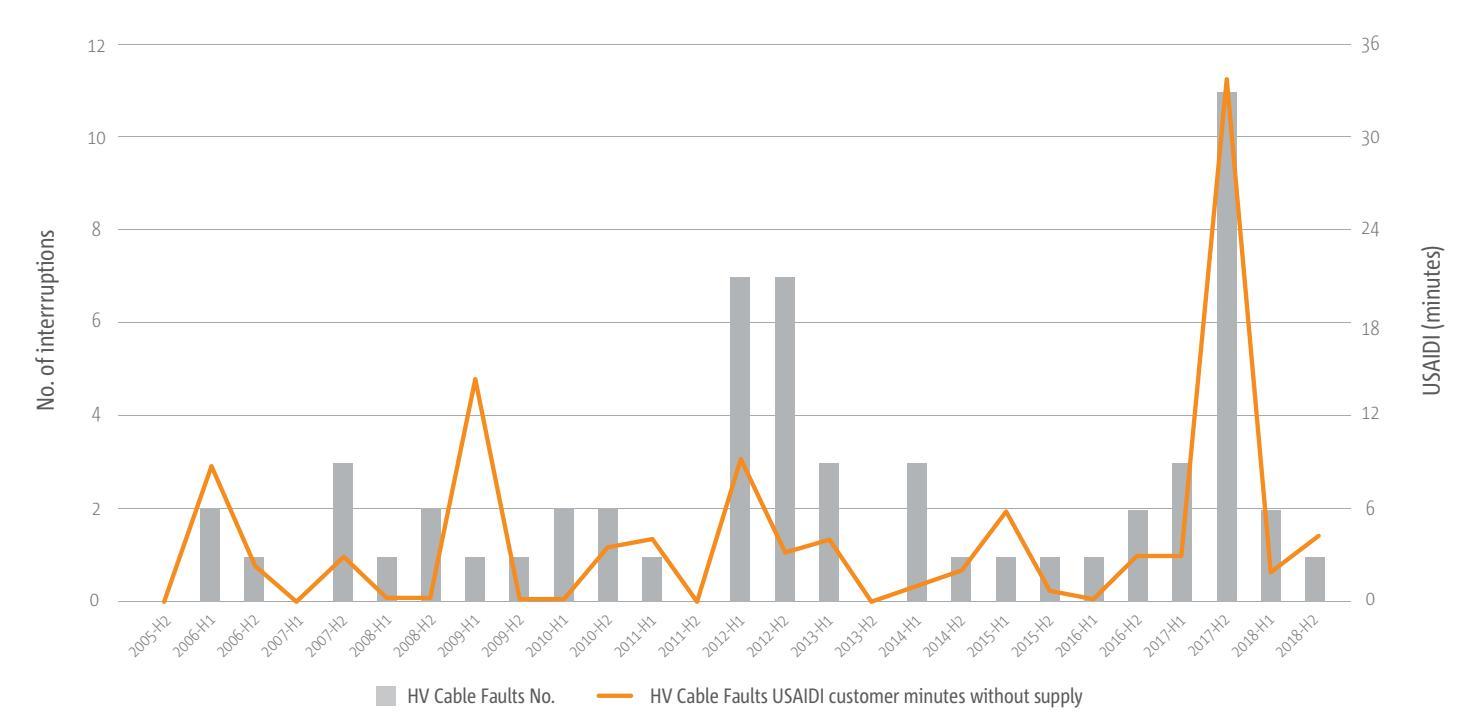
CBD HV Cables fault by half year (no. and USAIDI)

This graph (above) shows the spike in the number of cable faults in the second half of 2017. The average minutes (USAIDI) customers were without supply was unusual and has not been repeated in 2018.
